Issued September 29, 2022

MIR-22/24

# Engine Room Fire on board Towing Vessel *Capt. Kirby Dupuis*

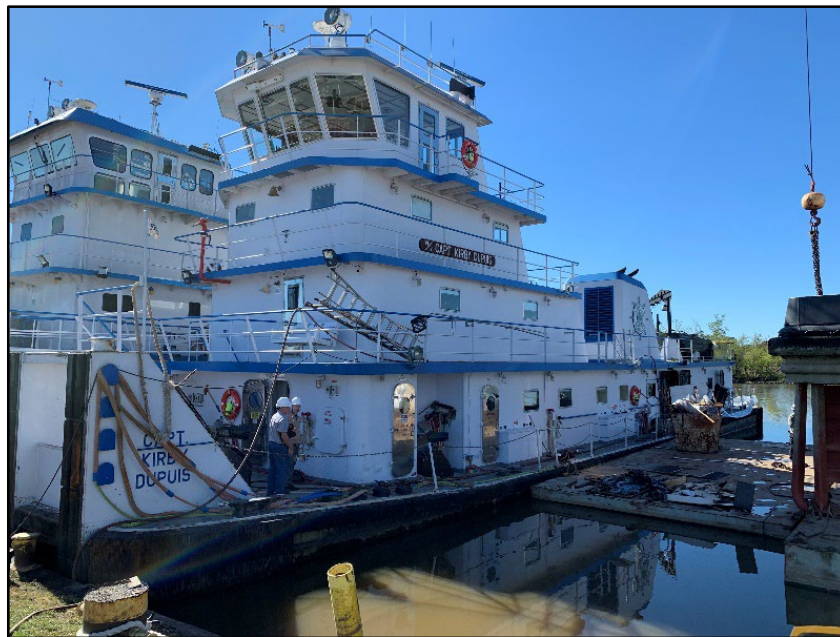
**Figure 1.** *Capt. Kirby Dupuis* docked after the casualty.

departments.<sup>2</sup> The fire caused extensive heat and smoke damage to the vessel's engine room. The upper and lower engine room bulkheads and overheads were completely burned by the fire as well as the machinery, fixtures, and equipment in the upper engine room. A marine surveyor estimated the damages to be 1.8 million dollars.

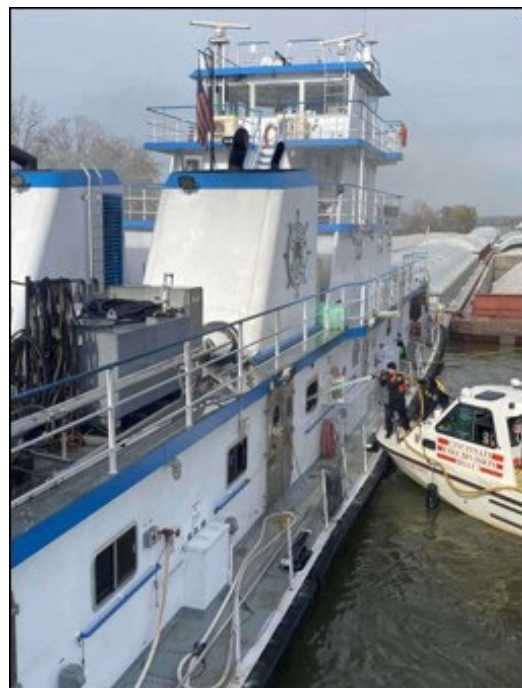
**Figure 3.** Firefighters deploying water into the engine room of the *Capt. Kirby Dupuis* through an open window. (Source: LT Meghan G. Keith, Dearborn County Water Rescue)

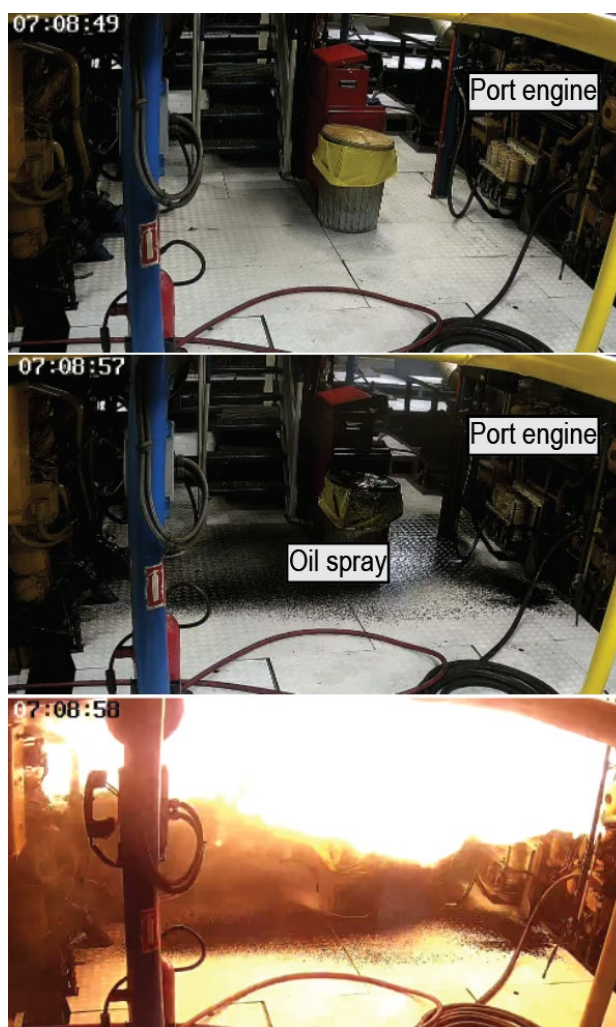
The day after the fire, investigators reviewed the vessel's video system. At 0708:50, lube oil began to spray inboard from the port main engine into the center of the engine room toward the starboard main engine. About 10 seconds later, a flame at the top of the forward part of the engine by the exhaust manifold erupted inboard toward the starboard engine. The video lasted about 1 minute, until the camera stopped recording.

**Figure 4.** Screenshots from the *Capt. Kirby Dupuis* engine room video camera (looking aft) at 0708:49-0708:58.

The engine room video showed that, within 10 seconds of the leak starting, the oil sprayed inboard into the center of the engine room and upward onto the exhaust manifold on top of the running engine. Immediately after contacting the hot surface of the exhaust manifold, the oil ignited and started the fire. Forced air from the running ventilation supply fan discharging above the engine fueled the fire with oxygen and propelled it across the engine room, damaging the starboard engine and the equipment in the upper engine room.

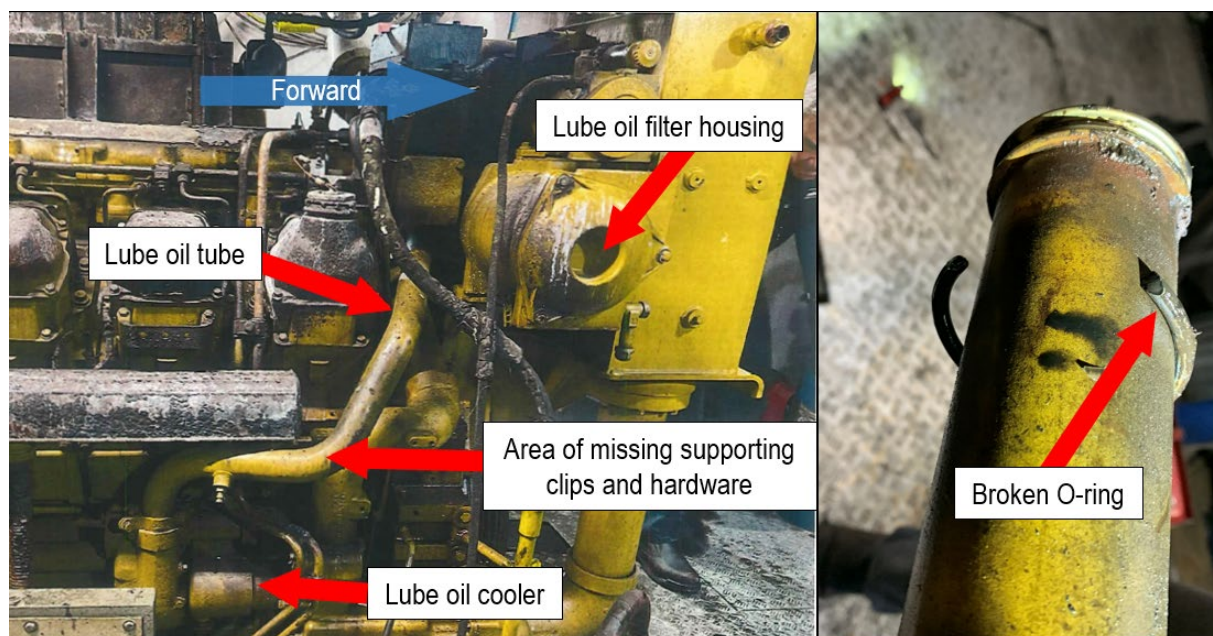
A senior technical service manager from Louisiana Cat (Caterpillar) reviewed the video and inspected the damaged port main engine. He found a broken piece of an O-ring seal on top of the front cover of the engine, directly below the upper joint area of a lube oil tube that connected the lube oil filter housing to the lube oil cooler. (The typical operating pressure of the system was about 55 pounds per square inch.)

**Figure 5.** Port main engine lube oil components (*left*). Port main engine lube oil tube with broken O-ring after removal on upper section of tube (*right*). (Source: Louisiana Cat, annotated by NTSB)

When the service manager removed the tube from the engine, he found the remainder of the broken O-ring and observed that the retaining ring, which should have been installed to secure the tube in its joint, was missing where the tube connected to the lube oil filter housing. It is unknown when the tube had last been removed from the engine. Upon further inspection, the technician discovered "wear to the seal O-ring groove lip" on the upper section of the removed tube.

The initial cause of the *Capt. Kirby Dupuis* port main engine (a Caterpillar model 3512C) fire was an oil leak from the pressurized lube oil system at the tube connection to the lube oil filter housing, which released oil that came in contact with a hot surface, likely the exhaust manifold on the engine. The retaining ring that was supposed to be installed behind the O-ring lip of the lube oil tube was missing, so the O-ring was not properly sealed nor supported in the joint for an unknown amount of time, leading to its failure. The wear found on the seal O-ring groove lip of the lube oil tube indicates that there was movement of the tube in the joint due to natural vibration of the operating engine. It is likely that at some installation, after maintenance that required removal of the tube, the retaining ring was not re-installed on the tube.

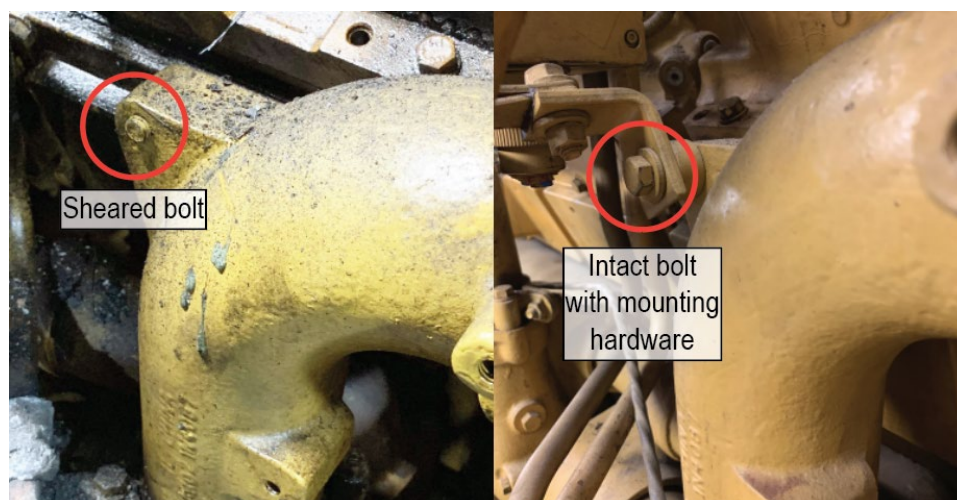
Additionally, supporting clips and mounting hardware for the lube oil tube were missing on the port main engine in the mid-section area, and the bolt that had held the supporting clips appeared to be sheared. The service manager's report concluded that the cause of the fire was "a severe oil leak" that sprayed onto the exhaust manifold of the port main engine near the no. 1 cylinder and ignited. "Ventilating air from the air duct above the [port main] engine supplied the fire with oxygen and blew the fire across the engine room damaging the stbd. [starboard] main engine."

**Figure 6.** Sheared bolt for lube oil tube mounting on *Capt. Kirby Dupuis* port main engine (left). Proper arrangement of supporting clips and mounting hardware on board similar FMT towing vessel *David McNemar* (right).

Additionally, the supporting clips and hardware were also missing from the mid-section of the lube oil tube, preventing it from being secured in accordance with the manufacturer's design. It is unknown how long the supporting clips and hardware had been missing from the engine. The last major work on this engine was in May 2018 when a top end overhaul was conducted, and it is possible that the oil tube was removed during that work. However, none of the parts associated with the tube were ordered at that time. A sheared bolt found postcasualty indicates that the supporting clips and hardware had originally been installed on the engine but had failed at some point. Without the supporting clips and hardware, the tube was unsupported in the mid-section area and more susceptible to vibration and associated movement.

Caterpillar 3512 main engines throughout their fleet for proper installation of supporting clips and mounting hardware on the lube oil tubes. About 10% of the inspected engines required attention and were corrected.

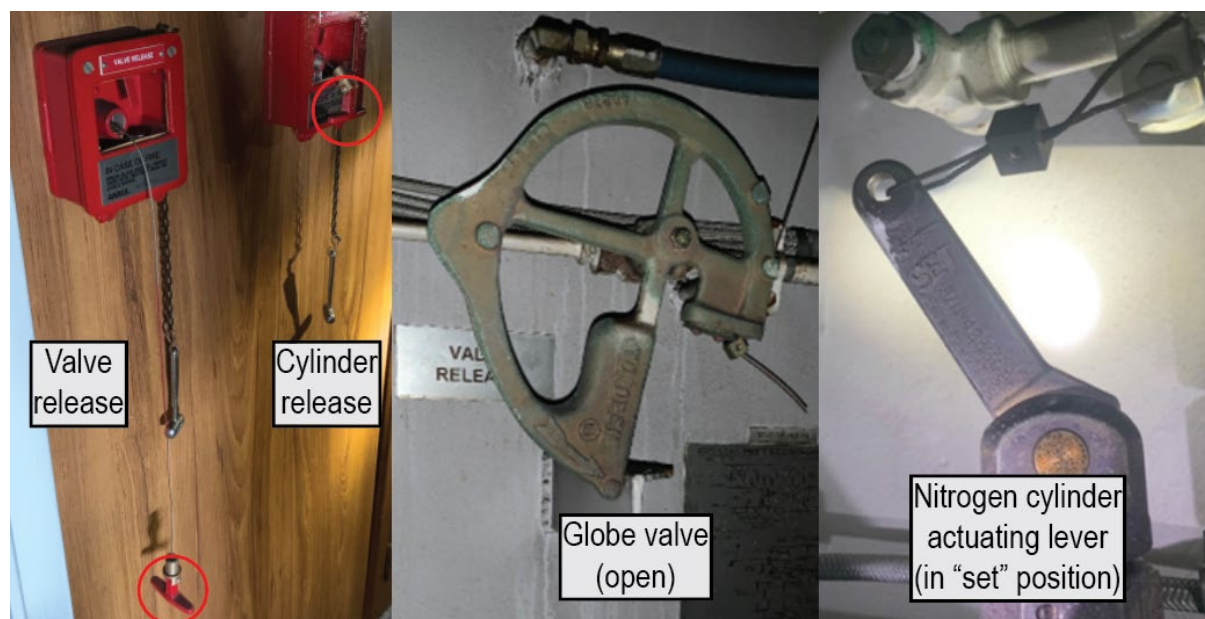
When investigators inspected the fire-extinguishing system, they observed that the "valve release" remote pull lever was pulled out as per the instructions, and its corresponding globe valve was open. However, the "cylinder release" remote pull lever was not fully extended, and its corresponding nitrogen cylinder's actuating lever remained in the "set" position.

**Figure 8.** Remote pull stations for *Capt. Kirby Dupuis's* fixed fire-extinguishing system as found after the fire. Red pull levers are circled (*left*). Globe valve in open position after the fire (*center*). Nitrogen cylinder's actuating lever in the "set" position as found after the fire (*right*). (Source: Coast Guard).

Although the crew attempted to activate the vessel's fixed fire-extinguishing system—and believed they had successfully discharged the fire suppression fluid—investigators determined that the system was not activated during the fire. After the fire, the nitrogen pilot cylinder lever was found in the "set" position and its cylinder was still fully charged. Both suppression fluid cylinders were also found full to capacity after the fire. Despite the deckineer stating that he pulled both remote pull levers, only the "valve release" lever was found to be fully extended; its attached cable properly opened the globe valve. However, the "cylinder release" remote pull valve handle was found only slightly extended from its stowed position in the cradle; therefore, the nitrogen gas from the pilot cylinder had not been discharged. Lacking pilot pressure, the sequence for release could not activate: the siren did not sound, and the remote shutdowns of the engines and ventilation fans were not activated.

None of the drills or procedures included familiarization or training on the fixed fire-extinguishing system. As of the date of this report, FMT is developing a training video on fixed fire-extinguishing systems that will become required training for their crews.
