Issued September 29, 2022

MIR-22/24

# Engine Room Fire on board Towing Vessel *Capt. Kirby Dupuis*

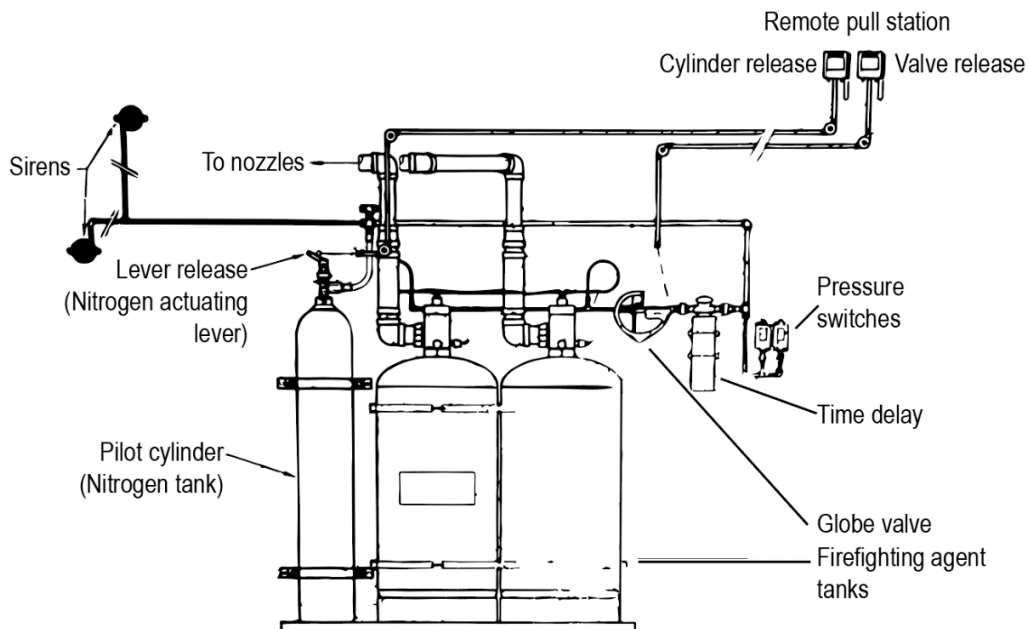
**Figure 7.** Schematic of *Capt. Kirby Dupuis* fixed fire-extinguishing system.

When investigators inspected the fire-extinguishing system, they observed that the "valve release" remote pull lever was pulled out as per the instructions, and its corresponding globe valve was open. However, the "cylinder release" remote pull lever was not fully extended, and its corresponding nitrogen cylinder's actuating lever remained in the "set" position.
